## EFFECTS OF CLIMATE CHANGE ON HISTORICAL BUILDING MATERIALS: ASSESSMENT AND SUSTAINABLE CONSERVATION SOLUTIONS

### Abstract:

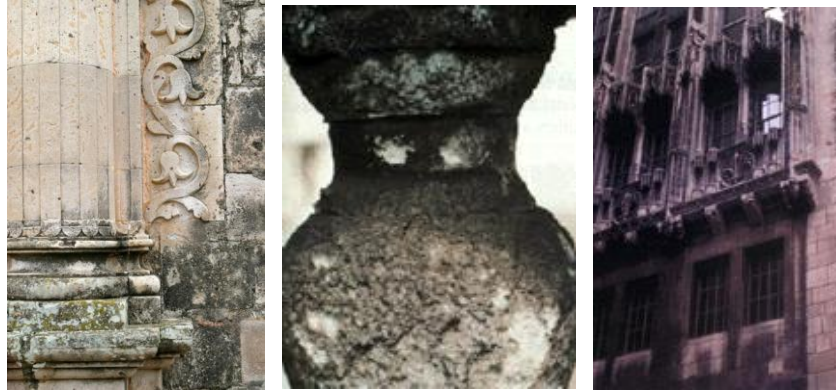
factors, threaten the physical and chemical structure of stone materials. Particularly carbonate stones (such as limestone, marble, travertine) are exposed to accelerated chemical dissolution processes due to increased acidic precipitation, leading to surface erosion and losses, micro and macro level cracks, and eventually irreversible structural weakening. These deterioration processes directly affect the original texture and durability of historical buildings, making conservation work more complex and costly [20]. Various deteriorations and erosions occurring in stones due to acid rain are shown in Figure 1 and Figure 2. These images demonstrate the chemical and physical changes caused by acid rain on stone surfaces.

Figure 1. The effect of acid rain on stones [21-22]

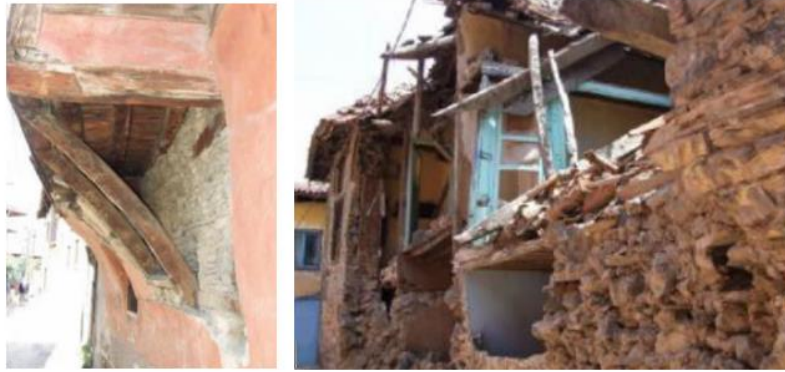
As shown in Figure 3, serious deformation problems have emerged in the load bearing systems of wooden structures due to continuously changing temperature and moisture conditions. Under these

challenging environmental conditions, the material properties of structural elements have changed over time, bending has begun in load bearing elements, and consequently, subsidence at various levels has occurred in different parts of the structure. This situation threatens the structural integrity of the building and requires immediate intervention.

Figure 3. Bending and sagging in wooden material [25].

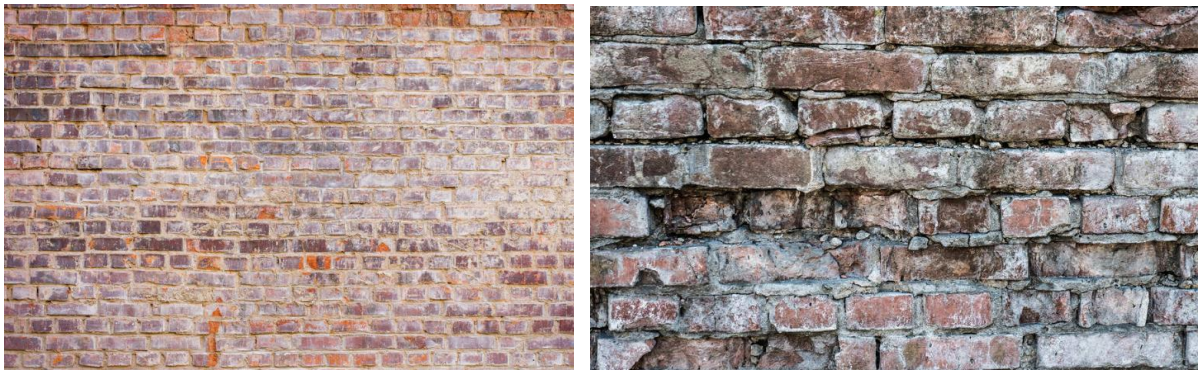
Traditional fired clay based brick and tile materials exhibit highly sensitive characteristics to water absorption and freeze thaw cycles due to their porous structure formed during the production process. The micro porous structure of these materials significantly affects their resistance to environmental impacts. As a consequence of climate change, increased severe rainfall, sudden temperature changes, and repeated freeze thaw cycles threaten the structural integrity of bricks, cause surface erosion, and lead to serious reduction in their mechanical strength over time. Additionally, chemical effects such as salt crystallization that building materials are exposed to can cause irreversible damage by leading to expansion and dissolution in the internal structure of bricks and tiles [22]. As shown in Figure 5, various

deteriorations and damages that occur over time in building materials, specifically in bricks and tiles, are visually presented.

Figure 5. Deterioration in brick and tile materials [27]

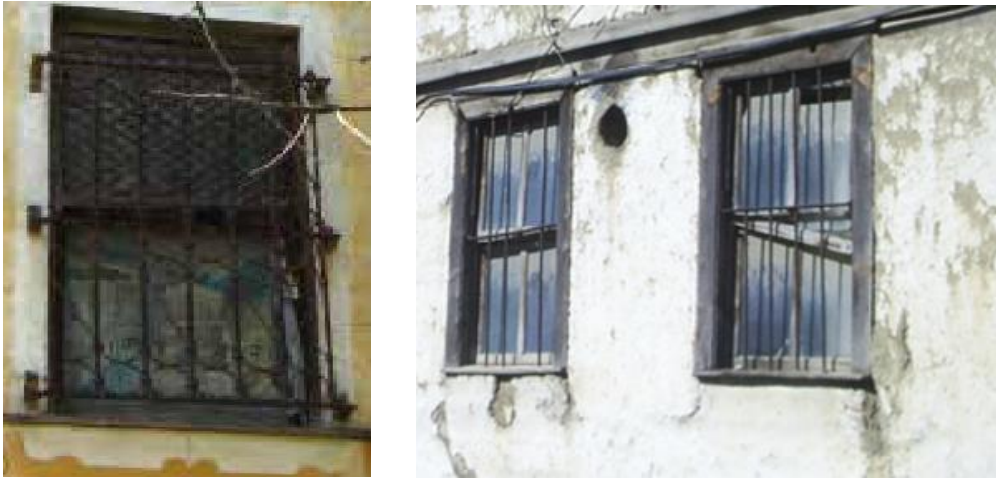
metal materials through chemical or electrochemical reactions under environmental factors. Wear, decay, and color changes have been observed on metal surfaces due to corrosion, significantly affecting the durability and functionality of the grilles.

Figure 6. Corrosion induced deterioration in metals [29]

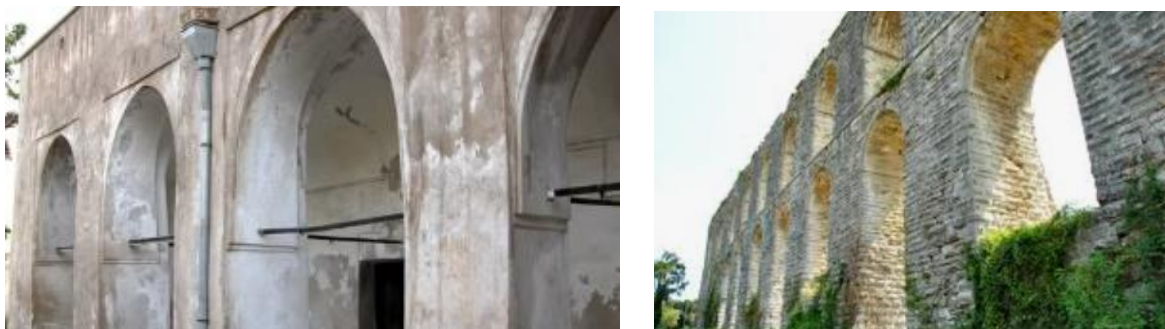
Lime based mortars and plasters used in historical buildings have a more porous structure compared to modern cement based materials and, due to these characteristics, exhibit much more sensitive behavior against water and moisture effects. The porous structure of these materials increases their interaction with external factors such as moisture and water, which threatens their structural integrity. As a result of climate change, the increase in atmospheric moisture content can cause serious damage to mortar and plaster layers. These damages include dissolution within the material, layer delamination, and loss of surface texture. Additionally, seasonal and daily temperature variations create thermal stresses in these sensitive materials. These thermal stresses can lead to the formation of micro cracks in the material structure over time, the growth of these cracks, and ultimately serious structural problems such as material detachment [30]. As shown in Figure 7, various damages in the mortar and plaster materials of buildings are illustrated. These damages manifest themselves as cracks, spalling, and decomposition observed on the wall surfaces of the buildings.

Figure 7. Deterioration in mortar and plaster materials [31].
